# Mapování degradace půdy a efektivity protierozních opatření v zóně Sidama, SNNPR, Etiopie

# Představení projektu

- Participativní rozvoj produktivní krajiny v rámci dotačního titulu: Komunitní a participativní hospodaření s vodními a přírodními zdroji v zóně Sidama, Etiopie (SNNPR)

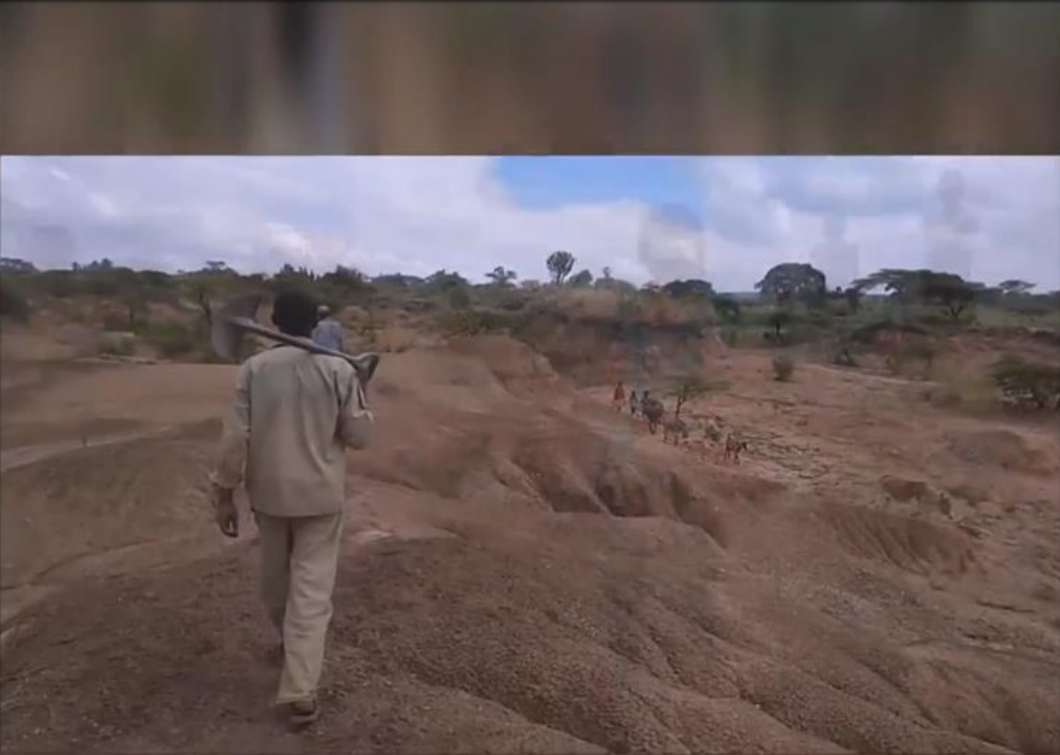
**The work is focused on:**

- > *Mapping of degraded areas (mostly CA)*
- > *Soil survey and sampling, analysis and evaluation → basic soil quality information*
- > *Soil and water conservation measures documentation 2017/2018*
- > *Designing Landscape management plans (LMP) - focus on watershed boundaries*
- > *Soil and water conservation measures recommendation*
